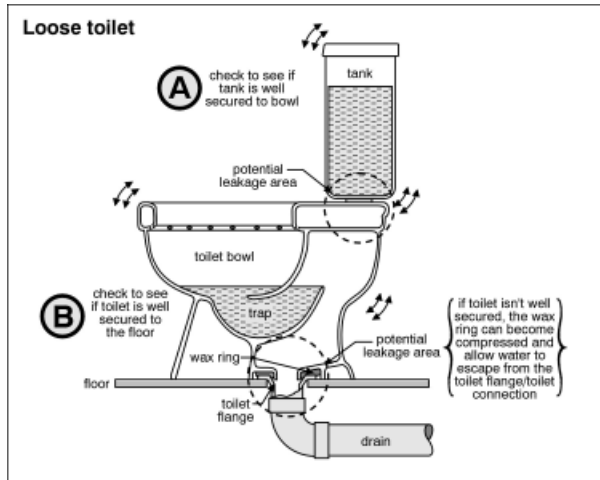
- **Repair:** The toilet is loose. The toilet should be removed and toilet seal replaced. Then the toilet fixed tightly back in place

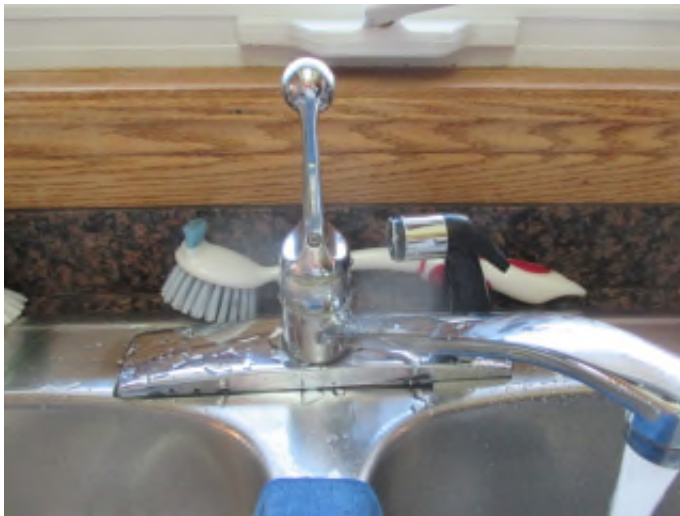
- **Repair:** The faucet and spout in the tub shower enclosure should be sealed with silicone to prevent water from penetrating the wall and causing damage to the interior of the wall
- **Repair:** The faucet(s) in the kitchen are leaking.

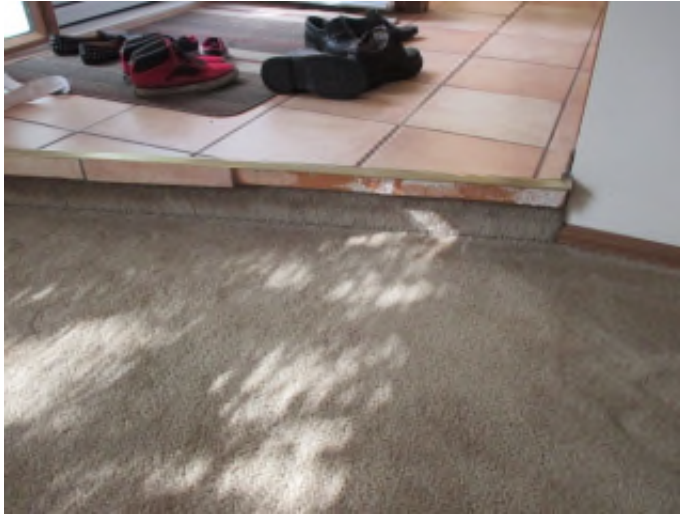
- **Monitor:** Typical drywall and painting flaws were observed.
- **Repair:** The tile floor is loose and/or missing.

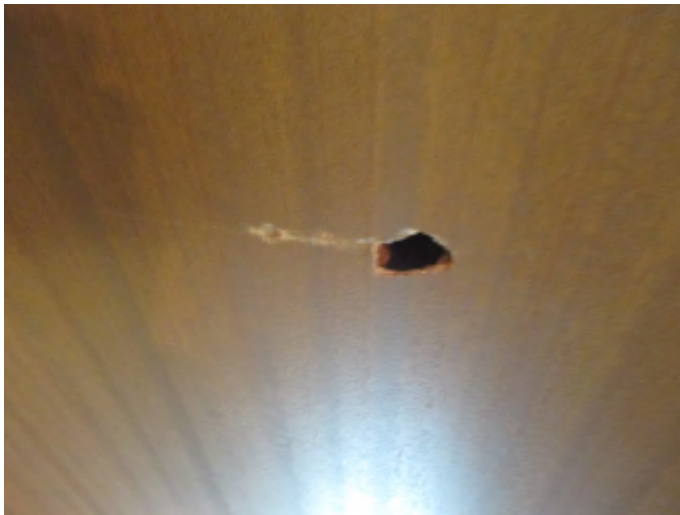
- **Repair:** The door is damaged in the master bed room

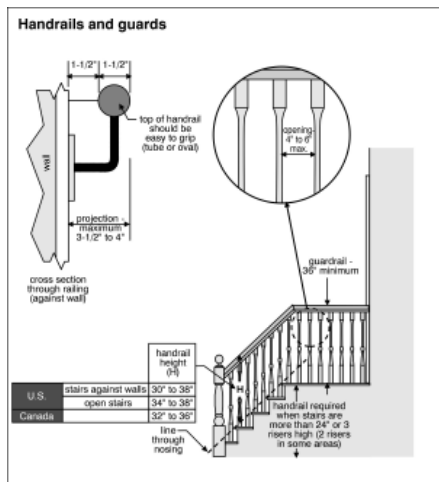
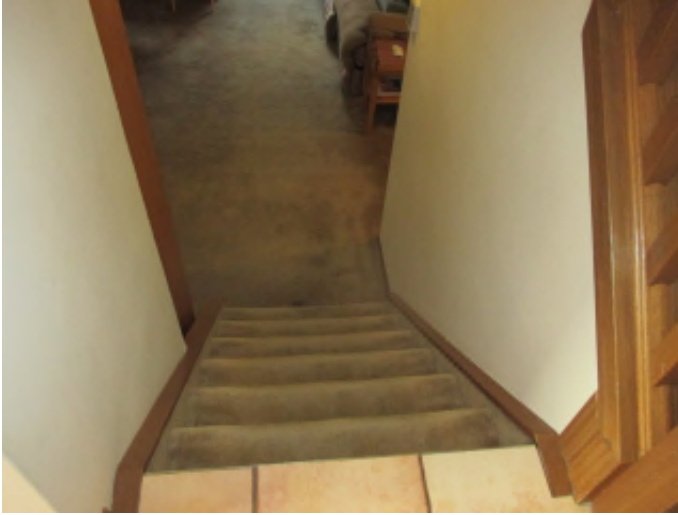
- **Repair, Safety Issue:** For improved safety, it is recommended that a handrail be provided for the stairway.

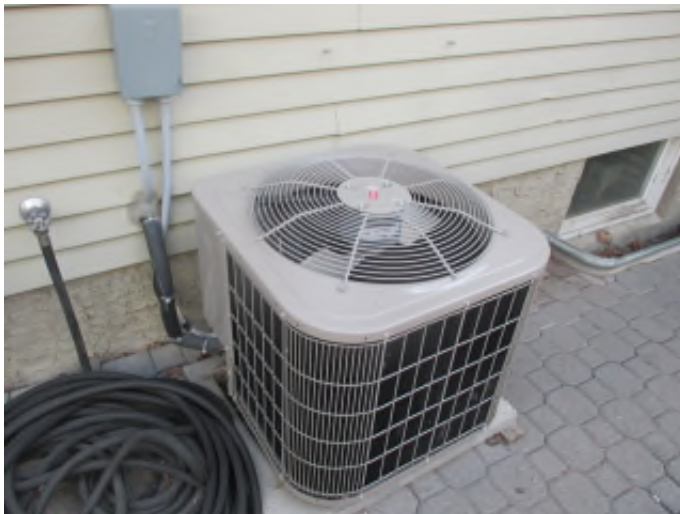
- The Air Conditioning system appears to be in good condition. No repairs or defects were observed at the time of inspection.
- **Improve:** It is recommended that the outdoor air conditioning unit have a cover installed during the winter months. This will help protect the units from dirt and water damage.
